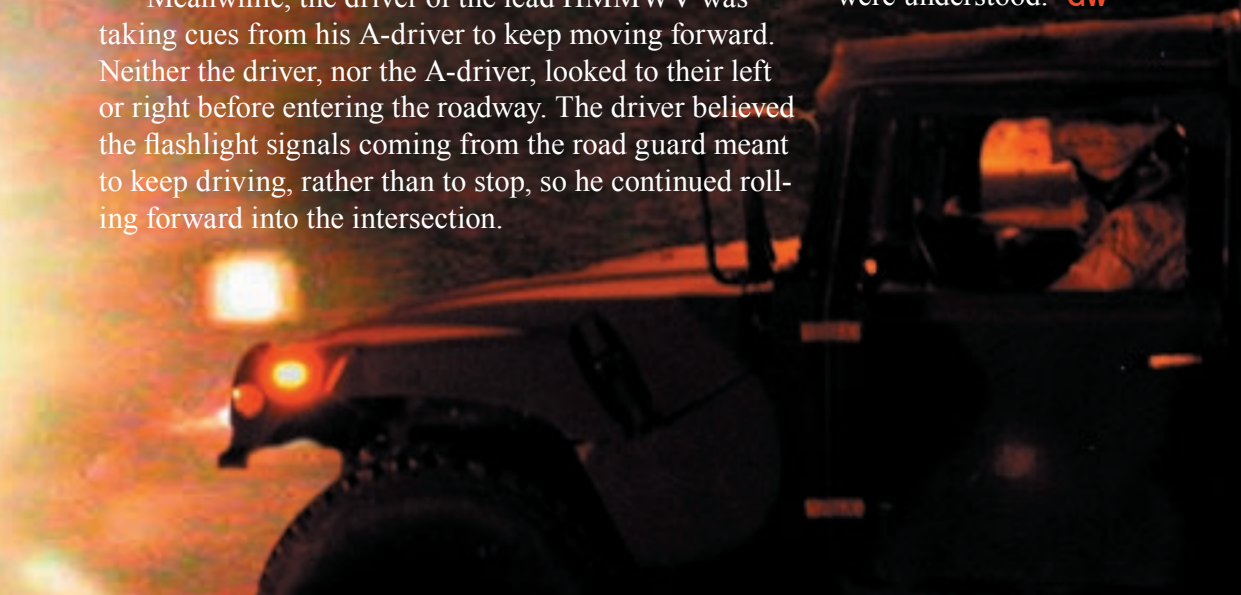
This collision left two Marines shaken up with minor injuries, two Marines with broken femurs, a totaled HMMWV, and a damaged civilian semi-truck. Based on the traffic investigation, the semi-truck was traveling approximately 55 mph at the time the driver slammed on his brakes. The impact pushed the HMMWV sideways almost 30 feet. Fortunately for the Marines in the HMMWV, the semi-truck only was carrying a forklift on a flatbed. If the semi-truck had been carrying a fully loaded trailer, the accident would have been much worse.

Why did this mishap occur? First, the unit did not follow its own plan to have signs posted at the intersection, indicating NVG driver training. Second, vehicles were not to cross the highway with blackout lights. If these precautions had been in place this way, all oncoming highway traffic would have been alerted of the training in the area. In the event that road guards had failed to stop the convoy, the oncoming traffic would have been able to see the convoy because they would have had their headlights on. Third, the road guards clearly did not understand their responsibilities. One of them believed he was supposed to stop the civilian traffic on the highway, while the other believed he was supposed to stop the convoy in case of oncoming traffic. Last, although the driver of the HMMWV was disoriented because he was wearing NVGs, he failed to look left or right before crossing the intersection.

The impact pushed the HMMWV sideways almost 30 feet.

Ultimately, this mishap could have been prevented if the unit had implemented their own plan and used the road signs, followed the local written procedures that prohibits crossing highways with blackout lights, and made sure the instructions of the road guards clearly were understood. **GW**
